**Flood Control Project Maintenance
Levee Inspections**
LMA District Cover Sheet
Spring 2019 Levee Inspection Results

Yolo County Service Area 6

Spring 2019 Levee Inspection Results

Waterway			Bank	Unit Miles
Unit No. 01 Right Bank of Sacramento River at Knights Landing			Right	5.87
	Spring (March - May)	Summer (June - August)	(September - November) Fall	Winter (December - February)
Unit Maintenance Rating (Fall Only)				
Date of Inspection	3/29/2019 - 3/29/2019			
DWR Inspector	Zach Jojola			
Accompanied By	Casey Leibler Yolo County			
	Thomas Engler MBK

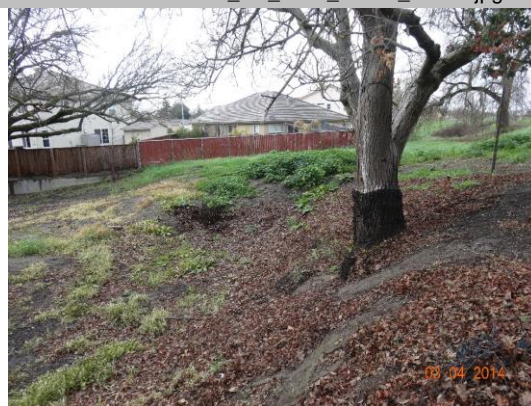
Photo 1 of 3 : UCIP_SP_2019_31903_58222.jpg

View of landward side.

Comment Code						
Inspector Comment						
FS_ID:31903 DS_ID:19515 EP_NO: 9425 Repair Type: Non-Urgent Crossing Status: Found UCIP Comments: Need to properly abandon crossing per Title 23-- pipe has been disconnected. No signs of pipe visible on waterward and landward sides. Need to contact owner to determine additional information about pipe section through levee. FIELD_STRUCT_DESC: *ABANDONED* 8-inch steel irrigation discharge pipe through the levee, 3 feet below the crown. Pump structure in the channel. 8-inch pipe replaced by a 4-inch pipe. (Retention of an 8-inch steel pipe through the levee and a pump on a platform on the waterside [WS] authorized under Automatic Board Order (ABO) issued as Permit No. 9425, 1974 - Albert E. Nuttall). [Additional Reference(s): DWR Levee Log, 2005]. FS Date: 3/4/2014

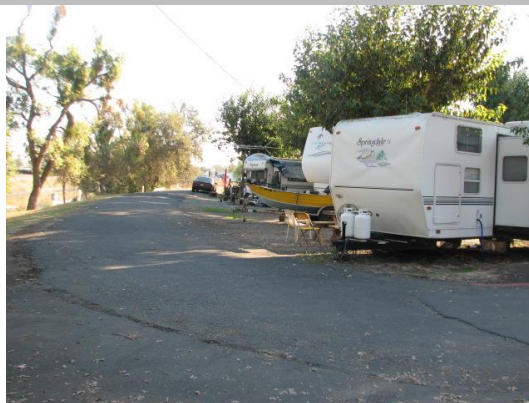
Photo 1 of 2 : SP_2019_NA0022_350_28_20190304_00013.jpg

LM Start	0.22	Rating **	M	Issue No.	28
LM End	0.25	Issue Type +	En	Location *	LS
Category	Earthen Levee			GPS Latitude/Longitude	
				Start	End
Item	Encroachments			38.801394 °	38.801613 °
				-121.721918 °	-121.721328 °
DWR ID	DWR_NA0022_01_s_2012_28				
Comment Code					
BU : Building					
Inspector Comment					
RV park runs on and along levee to bridge.

The RV park is encroached into the levee crown. Fall 2013

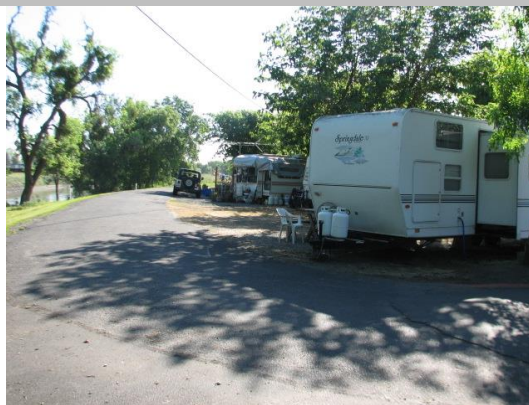
Photo 2 of 2 : SP_2019_NA0022_350_28_20190304_00014.jpg

Trailers on the crown of the levee. Spring 2014

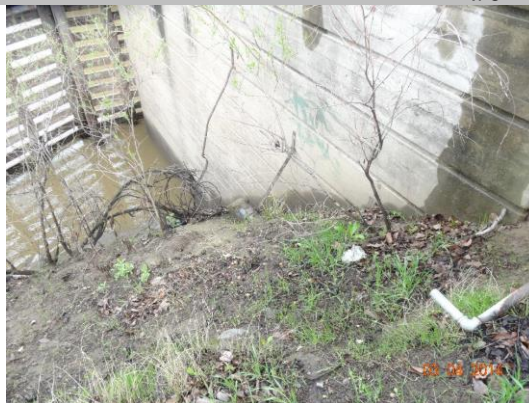
Photo 1 of 2 : UCIP_SP_2019_31906_58238.jpg

Comment Code					
Inspector Comment					
FS_ID:31906 DS_ID:19534 EP_NO: 17016 Repair Type: Non-Urgent Crossing Status: Indicator Found UCIP Comments: Unable to confirm crossing alignment--steel pipe visible on waterward side however, unable to confirm if crossing is the same one found during field confirmation. Need to contact owner to verify alignment and status of crossing. Slope was too steep to verify and obtain additional information about pipe. FIELD_STRUCT_DESC: Three 2-inch and three 1.5-inch fiber optics conduits through the levee, encased in a single high-density polyethylene (HDPE) casing, 30 feet below the crown. Concrete cap on each end of the HDPE casing. Voids in the HDPE casing grouted. (Plans to install three 2-inch and three 1.5-inch fiber optics conduits within a casing across and bored under the Sacramento River and its levees authorized under Permit No. 17016, 2000 - Worldwide Fiber). FS Date: 3/4/2014

Steel pipe located on waterward side--pipe disconnected.

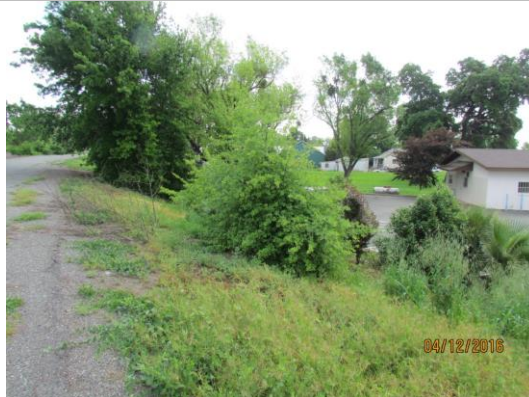
Photo 1 of 1 : SP_2019_NA0022_350_104_20190304_00051.jpg

LM Start	0.41	Rating **	M	Issue No.	104
LM End	0.43	Issue Type +	Ma	Location *	LS
Category	Earthen Levee			GPS Latitude/Longitude	
				Start	End
Item	Vegetation			38.802066 °	38.802126 °
				-121.718477 °	-121.718133 °
DWR ID	DWR_NA0022_01_s_2016_104				
Comment Code					
V2 : Remove the wild growth other than native grasses from the levee slopes.					
Inspector Comment

View of the tree on the landward side of the levee looking downstream. Spring 2016.

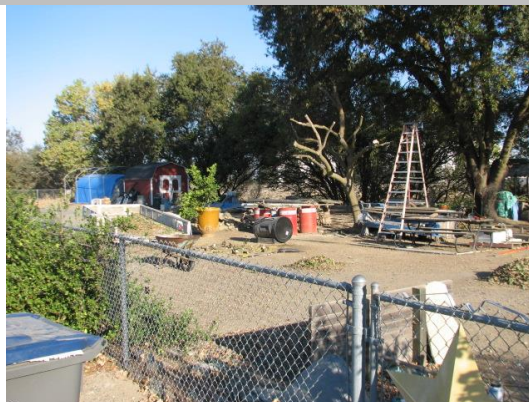
Photo 1 of 1 : SP_2019_NA0022_350_395_20190304_00062.jpg

LM Start	0.50	Rating **	M	Issue No.	395
LM End	0.54	Issue Type +	En	Location *	WS
Category	Earthen Levee			GPS Latitude/Longitude	
				Start	End
Item	Encroachments			38.802120 °	38.801882 °
				-121.716867 °	-121.716165 °
DWR ID	DWR_NA0022_01_f_2013_395				
Comment Code					
MA : Material					
Inspector Comment

Material blocking visibility on the waterside of the levee. Fall 2013

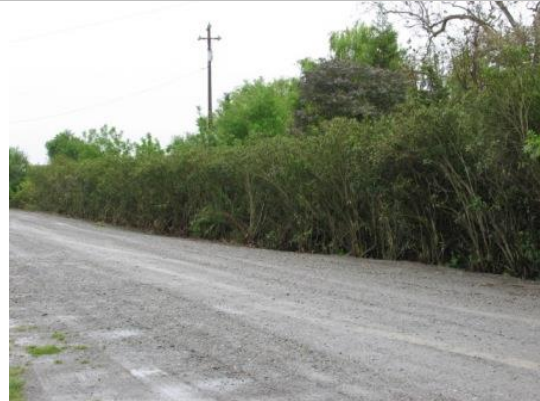
Photo 1 of 1 : SP_2019_NA0022_350_22_20190304_00009.jpg

LM Start	0.57	Rating **	U	Issue No.	22
LM End	0.72	Issue Type +	En	Location *	LS
Category	Earthen Levee			GPS Latitude/Longitude	
				Start	End
Item	Vegetation			38.801815 °	38.800928 °
				-121.715628 °	-121.712991 °
DWR ID	DWR_NA0022_01_s_2012_22				
Comment Code					
V6 : Landscaping					
Inspector Comment					
Oleander hedge completely blocks visibility and access on landside slope.

Oleanders along the shoulder.

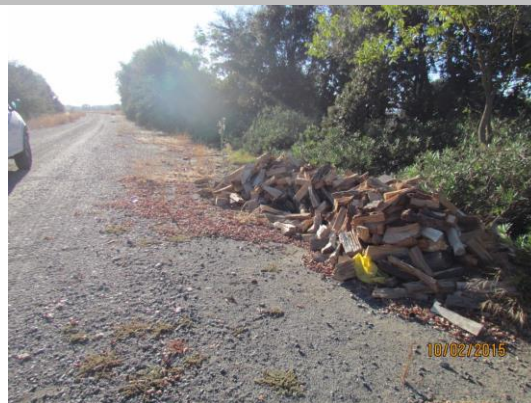
Photo 1 of 1 : SP_2019_NA0022_350_70_20190304_00034.jpg

LM Start	0.65	Rating **	M	Issue No.	70
LM End	0.65	Issue Type +	En	Location *	LS
Category	Earthen Levee			GPS Latitude/Longitude	
				Start	End
Item	Encroachments			38.801372 °	38.801372 °
				-121.714247 °	-121.714247 °
DWR ID	DWR_NA0022_01_f_2015_70				
Comment Code					
DE : Debris					
Inspector Comment

View of the firewood on the landward side of the levee looking downstream. Fall 2015.

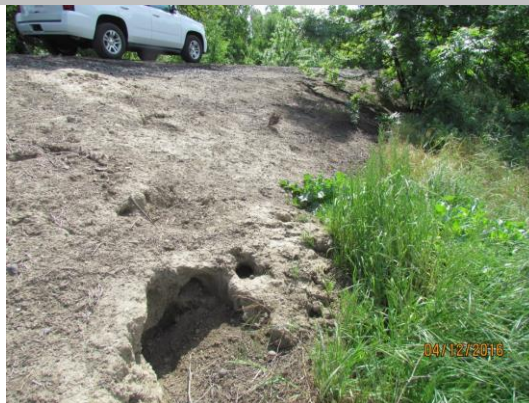
Photo 2 of 2 : SP_2019_NA0022_350_119_20190304_00056.jpg

LM Start	1.96	Rating **	M	Issue No.	119 (cont)	
LM End	1.96	Issue Type +	Ma	Location *	LS	
Category	Earthen Levee			GPS Latitude/Longitude		
				Start		End
Item	Animal Control			38.795418 °		38.795418 °
				-121.695964 °		-121.695964 °
DWR ID	DWR_NA0022_01_s_2016_119					
Comment Code						
A3 : No rodents visible, but rodent burrows visible; need to backfill and compact or grout burrows.						
Inspector Comment						
Multiple rodent holes are located on the landside slope near toe.

View of the rodent hole on the landward side of the levee. Spring 2016.

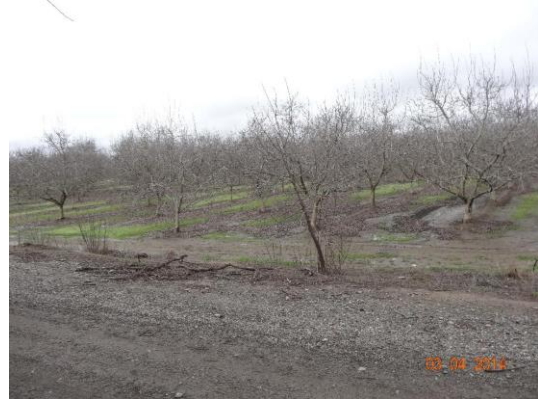
Photo 1 of 3 : UCIP_SP_2019_40536_58265.jpg

View of landward side.

Comment Code						
Inspector Comment						
FS_ID:40536 DS_ID:19524 EP_NO: 9413 Repair Type: Non-Urgent Crossing Status: Found UCIP Comments: Alignment through levee unknown--no signs of crossing through landward side. Need to contact owner to determine status of crossing. This crossing appears to have been updated since 1970s. FIELD_STRUCT_DESC: 24-inch pipe of an unknown material or purpose through the levee, 15.5 feet below the crown. Gate valve on the landside (LS) end. Ramp on the waterside (WS) slope. (Retention of a 30-inch pipe through the levee and a slide gate in a corrugated metal pipe [CMP] riser on both slopes authorized under Automatic Board Order (ABO) issued as Permit No. 9413, 1974 - Wallace Construction Company). Added appurtenances noticed in 2014: pump, metal frame platform, flow meter, and control panel on the WS. Appurtenances could be associated with Permit No. 12804. This appears to be the same entry as DS_ID 19538. [Additional Reference(s): DWR Levee Log, 2005]. FS Date: 3/4/2014

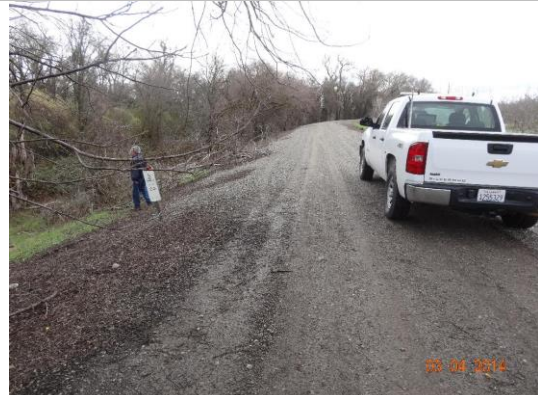
Photo 2 of 3 : UCIP_SP_2019_40536_58264.jpg

View of levee crown at crossing.

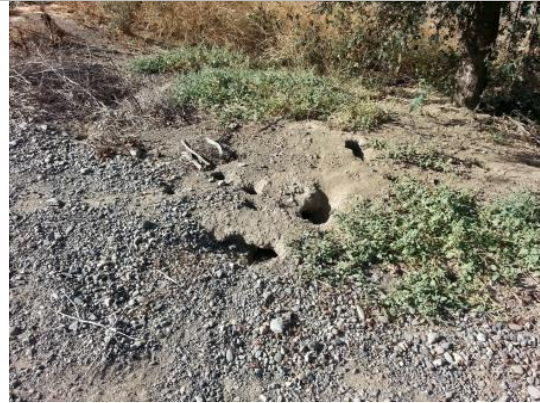
Photo 2 of 2 : SP_2019_NA0022_350_117_20190304_00054.jpg

LM Start	1.97	Rating **	M	Issue No.	117 (cont)	
LM End	2.06	Issue Type +	Ma	Location *	LS	
Category	Earthen Levee			GPS Latitude/Longitude		
				Start		End
Item	Animal Control			38.795234 °		38.793974 °
				-121.695898 °		-121.695852 °
DWR ID	DWR_NA0022_01_s_2016_117					
Comment Code						
A3 : No rodents visible, but rodent burrows visible; need to backfill and compact or grout burrows.						
Inspector Comment

Series of animal burrows on LS slope of the levee. Fall inspection 10/07/2016.

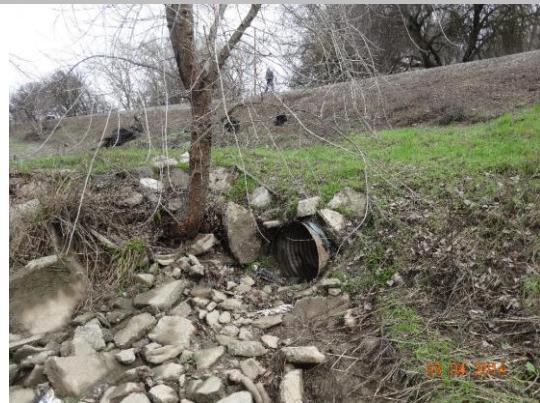
Photo 1 of 3 : UCIP_SP_2019_31632_57905.jpg

Comment Code					
Inspector Comment					
FS_ID:31632 DS_ID:19523 EP_NO: 9413 Repair Type: Non-Urgent Crossing Status: Indicator Found UCIP Comments: Erosion at outlet. Unable to determine if crossing is still in use. Will need to contact owner to determine status of crossing. FIELD_STRUCT_DESC: 30-inch corrugated metal gravity irrigation pipe through the levee, 13.5 feet below the crown. Slide gate on each end in a 48-inch corrugated metal pipe (CMP) riser. (Retention of a 30-inch pipe through the levee and a slide gate in a corrugated metal pipe [CMP] riser on both slopes authorized under Automatic Board Order (ABO) issued as Permit No. 9413, 1974 - Wallace Construction Company. Plans to relocate an existing incline irrigation pumping plant authorized under Permit No. 12804, 1979 - Wallace Construction Company). Pumping plant appears to be located at CLM 1.969, and pipe runs along the waterside (WS) berm and discharges into a ditch where the 30-inch pipe is used to convey the irrigation water to the landside (LS). [Additional Reference(s): DWR Levee Log, 2005]. FS Date: 3/4/2014

Outlet located on landward toe.

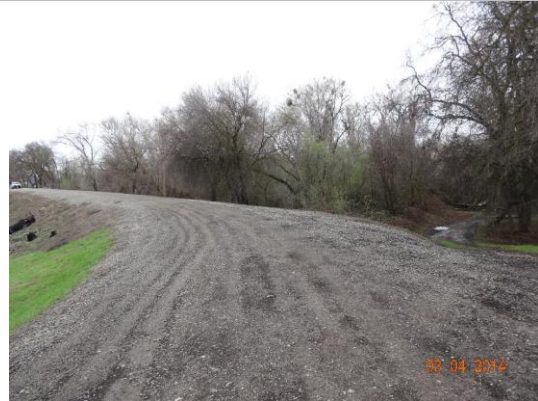
Photo 2 of 3 : UCIP_SP_2019_31632_57903.jpg

Overview of levee crown at crossing.

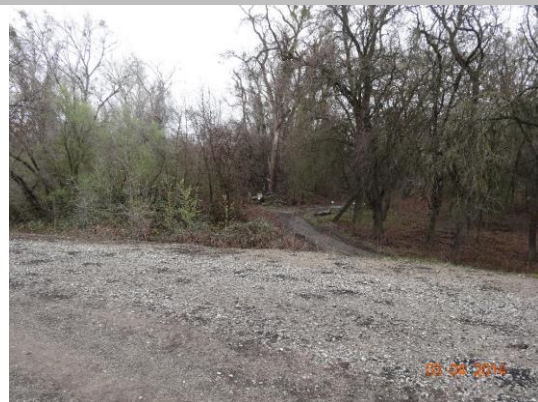
Photo 3 of 3 : UCIP_SP_2019_31632_57904.jpg

View of waterward side.

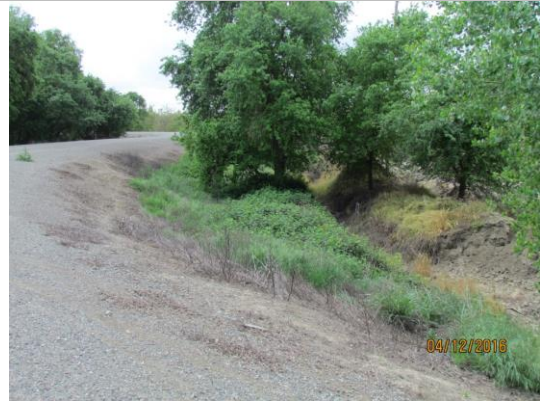
Photo 1 of 1 : SP_2019_NA0022_350_7_20190304_00002.jpg

LM Start	2.04	Rating **	M	Issue No.	7
LM End	2.14	Issue Type +	En	Location *	LS
Category	Earthen Levee			GPS Latitude/Longitude	
				Start	End
Item	Encroachments			38.794259 °	38.792907 °
				-121.695697 °	-121.696033 °
DWR ID	DWR_NA0022_01_s_2019_7				
Comment Code					
DT : Ditch					
Inspector Comment					
A ditch is located at the toe of the levee.

View of the ditch at the levee toe on the landward side looking downstream. Spring 2016.

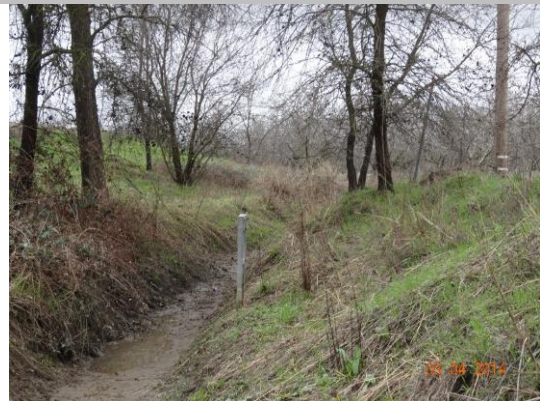
Photo 1 of 3 : UCIP_SP_2019_31915_58270.jpg

Comment Code					
Inspector Comment					
FS_ID:31915 DS_ID:19538 EP_NO: N/A Repair Type: Non-Urgent Crossing Status: Indicator Found UCIP Comments: Buried gate valve on landward slope. Crossing appears to be non-functional. Landward pipe section across canal has deteriorated. Will need to contact owner to determine status of crossing. If crossing is not in use owner will need to contact the CVFPB to abandon properly according to Title 23. FIELD_STRUCT_DESC: 20-inch corrugated metal gravity drainage pipe through the levee, at an unknown depth. 20-inch gate valve on the landside (LS) slope. This crossing could be the same record as DS_ID 19524 - unable to confirm. [Additional Reference(s): USACE Sacramento O&M Manual 127, June 1953, (Station 208+15)]. FS Date: 3/4/2014

Slide gate inside canal.

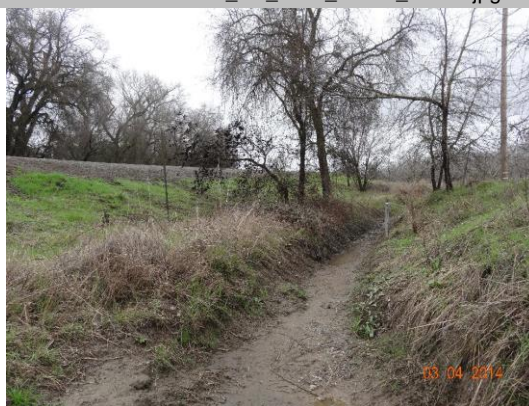
Photo 2 of 3 : UCIP_SP_2019_31915_58269.jpg

Comment Code						
Inspector Comment						
FS_ID:31915 DS_ID:19538 EP_NO: N/A Repair Type: Non-Urgent Crossing Status: Indicator Found UCIP Comments: Buried gate valve on landward slope. Crossing appears to be non-functional. Landward pipe section across canal has deteriorated. Will need to contact owner to determine status of crossing. If crossing is not in use owner will need to contact the CVFPB to abandon properly according to Title 23. FIELD_STRUCT_DESC: 20-inch corrugated metal gravity drainage pipe through the levee, at an unknown depth. 20-inch gate valve on the landside (LS) slope. This crossing could be the same record as DS_ID 19524 - unable to confirm. [Additional Reference(s): USACE Sacramento O&M Manual 127, June 1953, (Station 208+15)]. FS Date: 3/4/2014

View of canal runs parallel on landward toe.

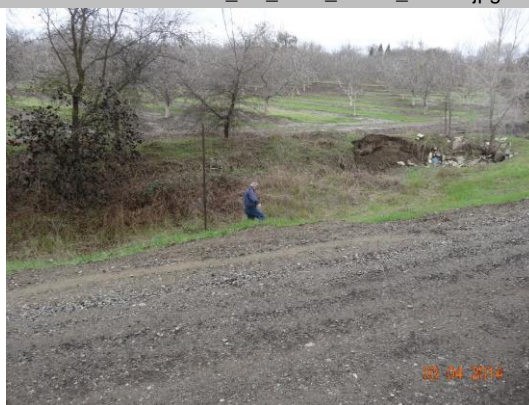
Photo 3 of 3 : UCIP_SP_2019_31915_58272.jpg

View of landward side.

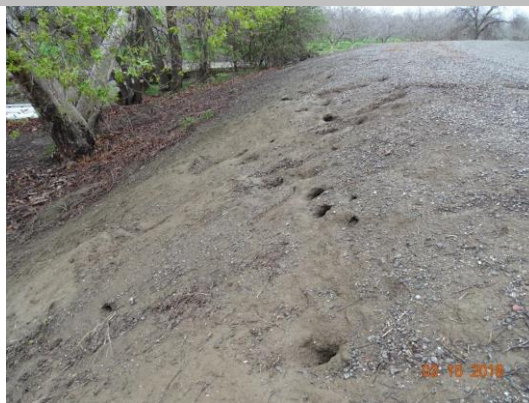
Photo 1 of 2 : SP_2019_NA0022_350_8_20190304_00003.jpg

LM Start	2.14	Rating **	M	Issue No.	8
LM End	2.18	Issue Type +	Ma	Location *	LS
Category	Earthen Levee			GPS Latitude/Longitude	
				Start	End
Item	Animal Control			38.792956 °	38.792520 °
				-121.696025 °	-121.695581 °
DWR ID	DWR_NA0022_01_s_2012_8				
Comment Code					
A3 : No rodents visible, but rodent burrows visible; need to backfill and compact or grout burrows.					
Inspector Comment					
There are more than 5 holes on the 25-foot stretch.

View of rodent holes on the landside slope. Spring 2018.

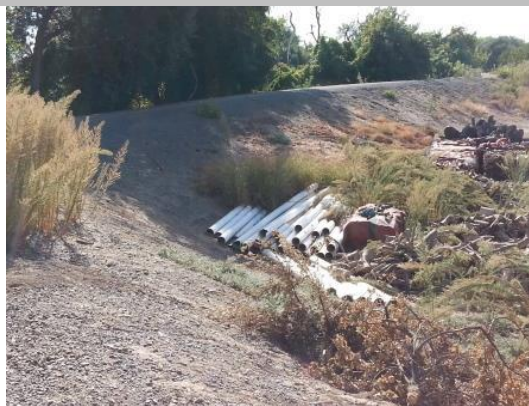
Photo 1 of 2 : SP_2019_NA0022_350_40_20190304_00021.jpg

LM Start	2.18	Rating **	M	Issue No.	40
LM End	2.18	Issue Type +	En	Location *	LS
Category	Earthen Levee			GPS Latitude/Longitude	
				Start	End
Item	Encroachments			38.792499 °	38.792499 °
				-121.695508 °	-121.695508 °
DWR ID	DWR_NA0022_01_s_2012_40				
Comment Code					
EQ : Equipment					
Inspector Comment					
Equipment is placed at the toe of the levee.

View of the equipment on landward side. Fall inspection 10/07/2016.

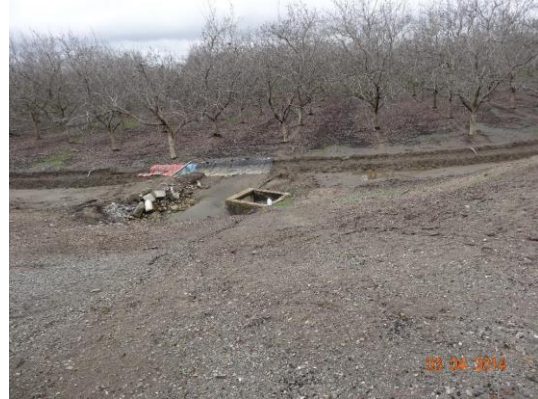
Photo 1 of 3 : UCIP_SP_2019_52726_57915.jpg

FS_ID:52726
DS_ID:19525
EP_NO: N/A
Repair Type: Urgent
Crossing Status: Found
UCIP Comments: 7/17/2018 Erosion near concrete box on LS did not progress, but still poses a threat to levee integrity. Recommend internal pipe inspection to determine pipe integrity through levee. (O.Yakimov-DWR UCIP)7/13/2016 same as last inspection. Erosion has progressed. Need to coordinate with owner to address erosion on LS toe. (DWR UCIP - omagana)3/04/2014 Surface erosion near concrete box on landward side. Unable to determine if crossing is leaking or if pump is pulling sand from waterward side. Need to contact owner to determine status of crossing and to check integrity of crossing. (DWR UCIP - omagana)
FIELD_STRUCT_DESC: 16-inch steel irrigation discharge pipe through the levee, 4 feet below the crown (1955 levee log indicates crossing is 18.9 feet below the crown). Concrete well and pump house on the waterside (WS). Screw gate in pump house. Slant pump mounted on a steel structure on the riverbank. 4-foot by 4-foot concrete discharge box on the landside (LS) toe. Overhead power line and anchor crosses levee. Pole on each shoulder. (Plans for installation of a pump on the bank and to utilize an existing discharge pipe through the levee authorized under Permit No. 5951, 1967 - Elizabeth Huston). [Additional Reference(s): DWR Levee Log, 2005. USACE Sacramento O&M Manual 127, June 1953, (Station 192+60)].

View of LS toe.

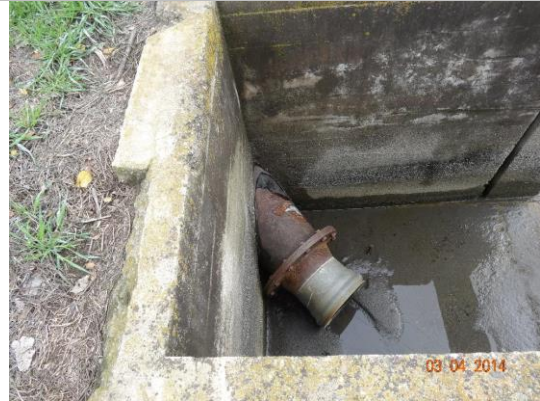
Photo 3 of 3 : UCIP_SP_2019_52726_57913.jpg

Comment Code					
Inspector Comment					
FS_ID:52726 DS_ID:19525 EP_NO: N/A Repair Type: Urgent Crossing Status: Found UCIP Comments: 7/17/2018 Erosion near concrete box on LS did not progress, but still poses a threat to levee integrity. Recommend internal pipe inspection to determine pipe integrity through levee. (O.Yakimov-DWR UCIP)7/13/2016 same as last inspection. Erosion has progressed. Need to coordinate with owner to address erosion on LS toe. (DWR UCIP - omagana)3/04/2014 Surface erosion near concrete box on landward side. Unable to determine if crossing is leaking or if pump is pulling sand from waterward side. Need to contact owner to determine status of crossing and to check integrity of crossing. (DWR UCIP - omagana) FIELD_STRUCT_DESC: 16-inch steel irrigation discharge pipe through the levee, 4 feet below the crown (1955 levee log indicates crossing is 18.9 feet below the crown). Concrete well and pump house on the waterside (WS). Screw gate in pump house. Slant pump mounted on a steel structure on the riverbank. 4-foot by 4-foot concrete discharge box on the landside (LS) toe. Overhead power line and anchor crosses levee. Pole on each shoulder. (Plans for installation of a pump on the bank and to utilize an existing discharge pipe through the levee authorized under Permit No. 5951, 1967 - Elizabeth Huston). [Additional Reference(s): DWR Levee Log, 2005. USACE Sacramento O&M Manual 127, June 1953, (Station 192+60)]. FS Date: 8/6/2018 8:28:18 AM

Outlet located on LS.

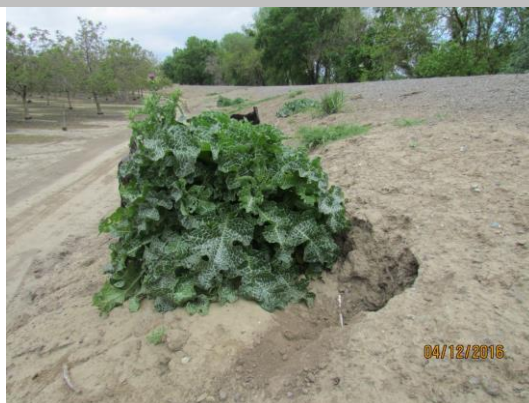
Photo 2 of 2 : SP_2019_NA0022_350_123_20190304_00058.jpg

LM Start	2.52	Rating **	U	Issue No.	123
LM End	2.52	Issue Type +	Ma	Location *	LS
Category	Earthen Levee			GPS Latitude/Longitude	
				Start	End
Item	Animal Control			38.787768 °	38.787768 °
				-121.694295 °	-121.694295 °
DWR ID	DWR_NA0022_01_s_2016_123				
Comment Code					
A3 : No rodents visible, but rodent burrows visible; need to backfill and compact or grout burrows.					
Inspector Comment

Perspective view of the rodent hole looking upstream. Spring 2016.

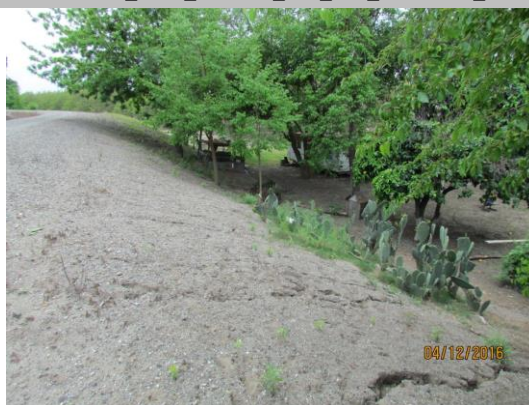
Photo 1 of 1 : SP_2019_NA0022_350_124_20190304_00059.jpg

LM Start	2.59	Rating **	M	Issue No.	124
LM End	2.59	Issue Type +	En	Location *	LS
Category	Earthen Levee			GPS Latitude/Longitude	
				Start	End
Item	Vegetation			38.786780 °	38.786780 °
				-121.694317 °	-121.694317 °
DWR ID	DWR_NA0022_01_s _ 2016_124				
Comment Code					
V6 : Landscaping					
Inspector Comment

View of the cacti and trees at the toe of the levee on the landward side looking downstream. Spring 2016.

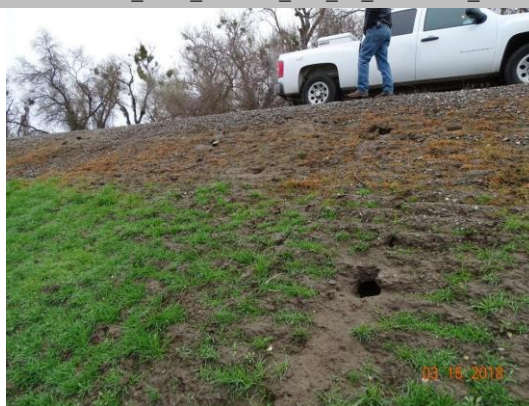
Photo 1 of 1 : SP_2019_NA0022_350_52_20190304_00030.jpg

LM Start	2.87	Rating **	M	Issue No.	52
LM End	2.89	Issue Type +	Ma	Location *	LS
Category	Earthen Levee			GPS Latitude/Longitude	
				Start	End
Item	Animal Control			38.783571 °	38.783345 °
				-121.692110 °	-121.691941 °
DWR ID	DWR_NA0022_01_f_2013_52				
Comment Code					
A1 : Exterminate rodents and backfill and compact or grout burrows.					
Inspector Comment

View of rodent holes on the landside slope. Spring 2018.

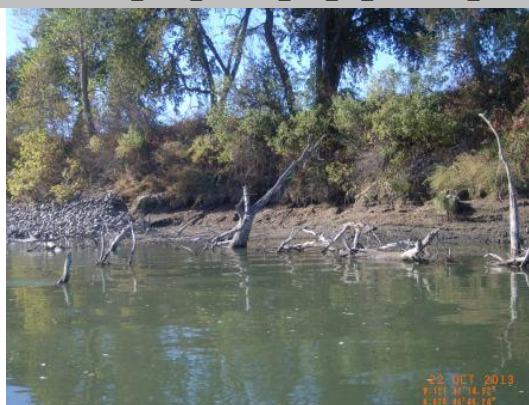
Photo 1 of 1 : SP_2019_NA0022_350_48_20190304_00028.jpg

LM Start	3.18	Rating **	A/W	Issue No.	48
LM End	3.28	Issue Type +	Ma	Location *	WS
Category	Supplemental			GPS Latitude/Longitude	
				Start	End
Item	2017 USACE Erosion Survey, DRAFT			38.780407 °	38.779137 °
				-121.688238 °	-121.687432 °
DWR ID	DWR_NA0022_01_f_2018_48				
Comment Code					
Inspector Comment					
2017 Site ID: SAC 86.9 R					
Status: Eroding					
2017 Field Notes: No observed change.					
Site History: 2006 - Short section is into the levee toe, rest is near the levee toe. Mass failure and fluvial erosion of depositional material. Rock at the upstream and downstream ends. 2011 - Minor new erosion. 2012 - Slope continues to steepen, tree roots have become exposed, and new eddy formed.

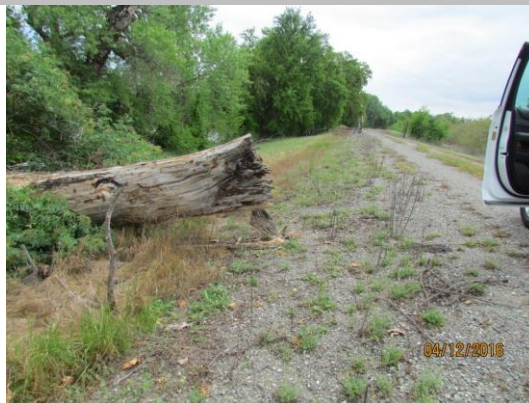
Photo 1 of 1 : SP_2019_NA0022_350_15_20190304_00008.jpg

LM Start	3.20	Rating **	M	Issue No.	15
LM End	3.20	Issue Type +	Ma	Location *	WS
Category	Earthen Levee			GPS Latitude/Longitude	
				Start	End
Item	Encroachments			38.780032 °	38.780032 °
				-121.688508 °	-121.688508 °
DWR ID	DWR_NA0022_01_s_2016_15				
Comment Code					
TR : Tree or limb					
Inspector Comment

View of the fallen tree on the waterward slope of the levee looking downstream. Spring 2016.

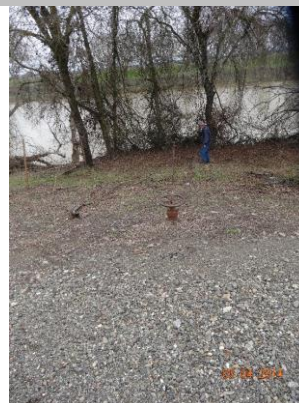
Photo 1 of 3 : UCIP_SP_2019_39858_71841.jpg

Comment Code					
Inspector Comment					
FS_ID:39858 DS_ID:19526 EP_NO: 3205 Repair Type: Non-Urgent Crossing Status: Found UCIP Comments: Need to contact owner to determine status of crossing. If crossing is no longer used need to coordinate with CVFPB for proper abandonment. FIELD_STRUCT_DESC: 12-inch coated steel irrigation discharge pipe through the levee, 4 feet below the crown. Metal cutoff wall. Pump on the waterside (WS). Gate valve on the WS slope. Siphon breaker in an 18-inch concrete riser on the landside (LS) slope. 36-inch concrete standpipe at the LS toe. (Previous pipe referenced as USACE O&M irrigation pipe, Station 144+80, was removed and a 12-inch pipe was reinstalled under Permit No. 3205, 1959 - Mary A. Richardson). [Additional Reference(s): DWR Levee Log, 2005. USACE Sacramento O&M Manual 127, June 1953, (Station 144+80)]. FS Date: 3/4/2014

View of waterward side.

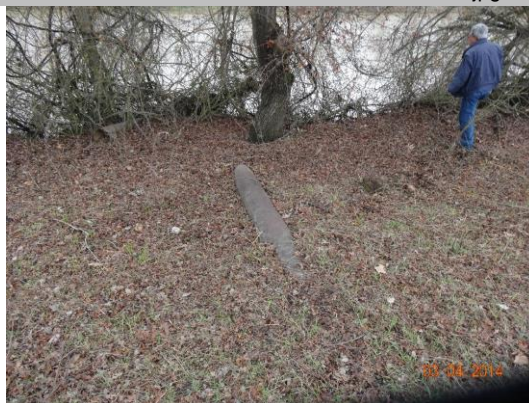
Photo 3 of 3 : UCIP_SP_2019_39858_71845.jpg

Comment Code						
Inspector Comment						
FS_ID:39858 DS_ID:19526 EP_NO: 3205 Repair Type: Non-Urgent Crossing Status: Found UCIP Comments: Need to contact owner to determine status of crossing. If crossing is no longer used need to coordinate with CVFPB for proper abandonment. FIELD_STRUCT_DESC: 12-inch coated steel irrigation discharge pipe through the levee, 4 feet below the crown. Metal cutoff wall. Pump on the waterside (WS). Gate valve on the WS slope. Siphon breaker in an 18-inch concrete riser on the landside (LS) slope. 36-inch concrete standpipe at the LS toe. (Previous pipe referenced as USACE O&M irrigation pipe, Station 144+80, was removed and a 12-inch pipe was reinstalled under Permit No. 3205, 1959 - Mary A. Richardson). [Additional Reference(s): DWR Levee Log, 2005. USACE Sacramento O&M Manual 127, June 1953, (Station 144+80)]. FS Date: 3/4/2014

Pipe section visible on waterward side.

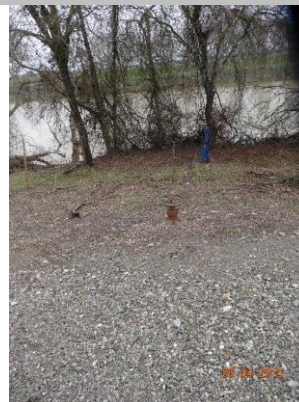
Photo 2 of 3 : UCIP_SP_2019_31916_58274.jpg

View of waterward side.

Comment Code						
Inspector Comment						
FS_ID:31916 DS_ID:19545 EP_NO: N/A Repair Type: Non-Urgent Crossing Status: Indicator Found UCIP Comments: Need to contact owner--Crossing appears to be abandoned. If crossing is no longer in use, crossing need to be abandoned properly per Title 23. FIELD_STRUCT_DESC: *REMOVED* 12-inch steel irrigation discharge pipe through the levee, at an unknown depth. Pump on the waterside (WS). Concrete standpipe on the landside (LS). (Previous pipe referenced as USACE O&M irrigation pipe, Station 144+80, was removed and a 12-inch pipe was reinstalled under Permit No. 3205, 1959 - Mary A. Richardson). [Additional Reference(s): USACE Sacramento O&M Manual 127, June 1953, (Station 144+80)]. FS Date: 3/4/2014

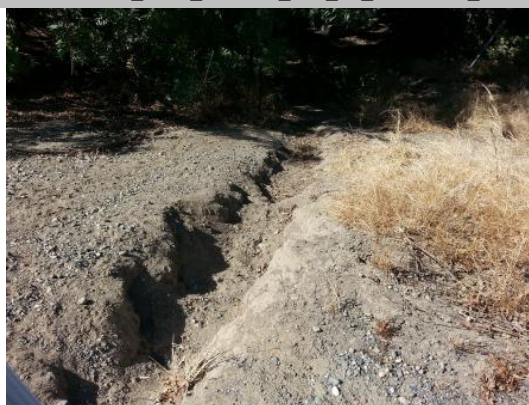
Photo 1 of 3 : SP_2019_NA0022_350_79_20190304_00038.jpg

LM Start	3.41	Rating **	M	Issue No.	79
LM End	3.41	Issue Type +	Ma	Location *	LS
Category	Earthen Levee			GPS Latitude/Longitude	
				Start	End
Item	Erosion / Bank Caving			38.777204 °	38.777204 °
				-121.687045 °	-121.687045 °
DWR ID	DWR_NA0022_01_s_2015_79				
Comment Code					
Inspector Comment					
This issue was originally added as a stairway notched into the levee. Since 2016 it has become an erosion issue.

View of erosion on the landside slope. Fall 2016.

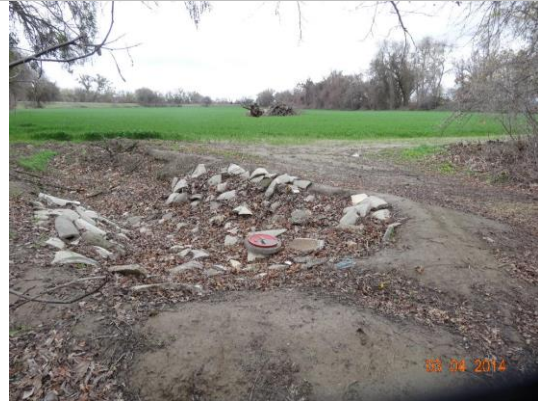
Photo 2 of 3 : UCIP_SP_2019_52727_58282.jpg

Comment Code						
Inspector Comment						
FS_ID:52727 DS_ID:19527 EP_NO: 3729 Repair Type: Non-Urgent Crossing Status: Found UCIP Comments: 07/17/2018 Section of WS levee slope that was disturbed during flow meter installation was backfilled but not compacted properly. Due to this, crossing downgraded to "Non-Urgent". Water pump was running during inspection, no leaks detected. (O.Yakimov-DWR UCIP)10/24/2017 Received updated photos of site from DWR levee inspector, Z. Jojola. Photos show levee slope has been disturbed where the flow meter is attached to pipe on the WS and section of the levee has not been backfill per Title 23 requirements. Recommend contacting the owner and coordinating with LMA about the issue. Crossing has been upgraded from Non-Urgent to Urgent due to disturbance of levee section. (DWR UCIP - O. Magana)03/04/2014 Crossing has been modified. Need to contact owner to determine additional information pertaining to the modifications. (DWR UCIP - O. Magana) FIELD_STRUCT_DESC: 10-inch irrigation discharge pipe of an unknown material through the levee, 3 feet below the crown. Metal cutoff wall. 1.5-inch electrical conduit through the levee, 1 foot below the crown. Service pole and meter at the landside (LS) toe. Pump and gate valve on the riverbank with an access ramp. Siphon breaker in a 12-inch concrete riser on the LS shoulder. (Plans for installation of a 10-inch centrifugal pump on the bank with a discharge pipe through the levee authorized under Permit No. 3729, 1961 - Clayton Russell). [Additional Reference(s): DWR Levee Log, 2005]. FS Date: 7/17/2018

View of landward side, photo 2 of 2.

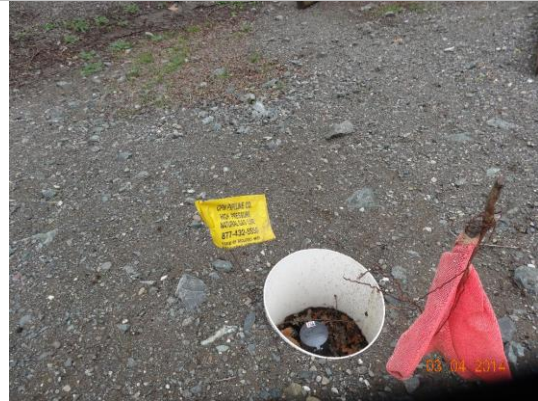
Photo 3 of 3 : UCIP_SP_2019_52727_58281.jpg

Comment Code						
Inspector Comment						
FS_ID:52727 DS_ID:19527 EP_NO: 3729 Repair Type: Non-Urgent Crossing Status: Found UCIP Comments: 07/17/2018 Section of WS levee slope that was disturbed during flow meter installation was backfilled but not compacted properly. Due to this, crossing downgraded to "Non-Urgent". Water pump was running during inspection, no leaks detected. (O.Yakimov-DWR UCIP)10/24/2017 Received updated photos of site from DWR levee inspector, Z. Jojola. Photos show levee slope has been disturbed where the flow meter is attached to pipe on the WS and section of the levee has not been backfill per Title 23 requirements. Recommend contacting the owner and coordinating with LMA about the issue. Crossing has been upgraded from Non-Urgent to Urgent due to disturbance of levee section. (DWR UCIP - O. Magana)03/04/2014 Crossing has been modified. Need to contact owner to determine additional information pertaining to the modifications. (DWR UCIP - O. Magana) FIELD_STRUCT_DESC: 10-inch irrigation discharge pipe of an unknown material through the levee, 3 feet below the crown. Metal cutoff wall. 1.5-inch electrical conduit through the levee, 1 foot below the crown. Service pole and meter at the landside (LS) toe. Pump and gate valve on the riverbank with an access ramp. Siphon breaker in a 12-inch concrete riser on the LS shoulder. (Plans for installation of a 10-inch centrifugal pump on the bank with a discharge pipe through the levee authorized under Permit No. 3729, 1961 - Clayton Russell). [Additional Reference(s): DWR Levee Log, 2005]. FS Date: 7/17/2018

Flow meter located on waterward shoulder.

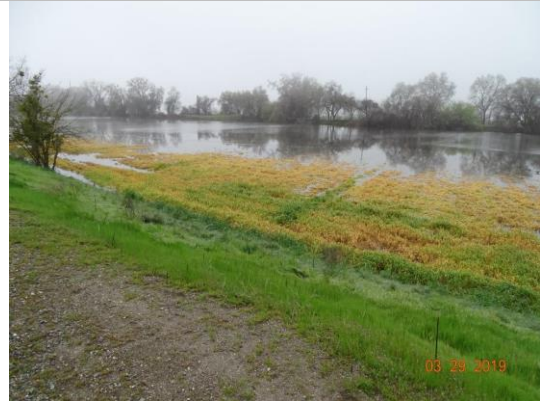
Photo 1 of 1 : SP_2019_NA0022_350_67_20190329_00129.jpg

LM Start	3.41	Rating **	U	Issue No.	67
LM End	3.91	Issue Type +	Ob	Location *	LS
Category	Earthen Levee			GPS Latitude/Longitude	
				Start	End
Item	Seepage / Sandboils			38.777152 °	38.771140 °
				-121.686942 °	-121.691150 °
DWR ID	DWR_NA0022_01_s_2019_67				
Comment Code					
Inspector Comment					
Significant seepage within the landside field.

View of seepage in the adjacent landside field. Spring 2019.

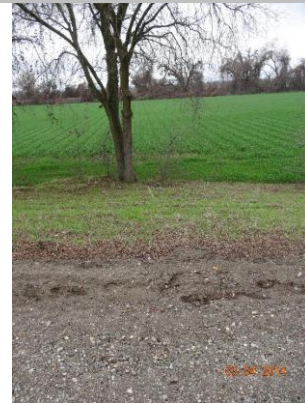
Photo 1 of 3 : UCIP_SP_2019_38996_69568.jpg

Comment Code					
Inspector Comment					
FS_ID:38996 DS_ID:19528 EP_NO: 3722 Repair Type: Non-Urgent Crossing Status: Found UCIP Comments: Pipe visible only on waterward side--Pipe needs to be properly abandoned per Title 23. Need to contact owner to determine status of crossing. FIELD_STRUCT_DESC: *ABANDONED* 10-inch steel irrigation discharge pipe through the levee, 3 feet below the crown. Metal cutoff walls at centerline of levee. 1.5-inch electrical conduit through the levee, 1 foot below the crown. Pump and gate valve on the riverbank. Siphon breaker in a 12-inch concrete riser on the landside (LS) shoulder. Pipe connects to an existing 24-inch concrete standpipe at the LS toe. (Plans for construction of a pumping plant on the bank authorized under Permit No. 3722, 1961 - Glen L. and Duane P. Traganza). No standpipe found at the LS toe. In the 1955 levee log, the crossing was referenced as a 10-inch pipe, 5.3 feet below the crown, at HLM 3.60. [Additional Reference(s): DWR Levee Log, 2005]. FS Date: 3/4/2014

View of landward side.

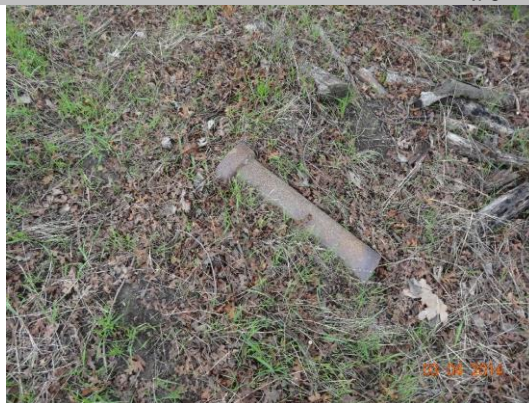
Photo 2 of 3 : UCIP_SP_2019_38996_69567.jpg

Comment Code						
Inspector Comment						
FS_ID:38996 DS_ID:19528 EP_NO: 3722 Repair Type: Non-Urgent Crossing Status: Found UCIP Comments: Pipe visible only on waterward side--Pipe needs to be properly abandoned per Title 23. Need to contact owner to determine status of crossing. FIELD_STRUCT_DESC: *ABANDONED* 10-inch steel irrigation discharge pipe through the levee, 3 feet below the crown. Metal cutoff walls at centerline of levee. 1.5-inch electrical conduit through the levee, 1 foot below the crown. Pump and gate valve on the riverbank. Siphon breaker in a 12-inch concrete riser on the landside (LS) shoulder. Pipe connects to an existing 24-inch concrete standpipe at the LS toe. (Plans for construction of a pumping plant on the bank authorized under Permit No. 3722, 1961 - Glen L. and Duane P. Traganza). No standpipe found at the LS toe. In the 1955 levee log, the crossing was referenced as a 10-inch pipe, 5.3 feet below the crown, at HLM 3.60. [Additional Reference(s): DWR Levee Log, 2005]. FS Date: 3/4/2014

Debris scattered on landward side.

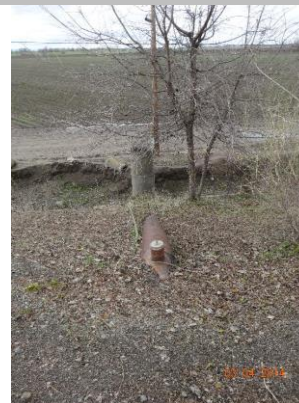
Photo 1 of 3 : UCIP_SP_2019_38999_57948.jpg

Comment Code					
Inspector Comment					
FS_ID:38999 DS_ID:19529 EP_NO: 4570 Repair Type: Non-Urgent Crossing Status: Found UCIP Comments: Need to contact owner to determine status of crossing. CMP riser damage on waterward slope. FIELD_STRUCT_DESC: 16-inch steel irrigation discharge pipe through the levee, 5 feet below the crown. Metal plate welded on the waterside (WS) end. Pump, 1.5-inch electrical conduit, and gate valve in a concrete U-shaped headwall are located on the riverbank. (Plans to replace existing pump on the riverbank authorized under Permit 7618-A, 1974 - Wallace Construction Company, Inc., care of Laugenour and Meikle). Pipe extends from the pump to a concrete standpipe on the landside (LS). Pipe exposed on the LS slope. Water meter in a 36-inch corrugated metal pipe (CMP) riser on the WS slope. Siphon breaker in a 7-inch metal riser on the LS shoulder. 30-inch concrete riser at the LS toe. Metal cutoff wall installed. (Plans for construction of a pumping plant with a discharge pipe through the levee authorized under Permit No. 4570, 1964 - England Brothers). [Additional Reference(s): DWR Levee Log, 2005]. FS Date: 3/4/2014

View of landward side.

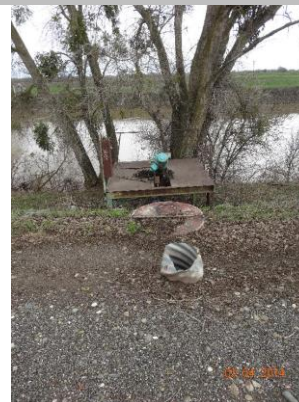
Photo 2 of 3 : UCIP_SP_2019_38999_57947.jpg

View of waterward side.

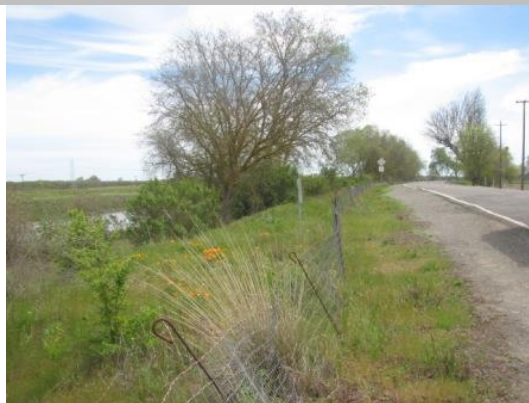
Photo 1 of 2 : SP_2019_NA0022_350_36_20190304_00017.jpg

LM Start	4.25	Rating **	A/W	Issue No.	36
LM End	4.49	Issue Type +	Ob	Location *	WS
Category	Earthen Levee			GPS Latitude/Longitude	
				Start	End
Item	Vegetation			38.767125°	38.764582°
				-121.693267°	-121.690285°
DWR ID	DWR_NA0022_01_f_2017_36				
Comment Code					
V8 : Environmental Requirements.					
Inspector Comment

Another view of the site.

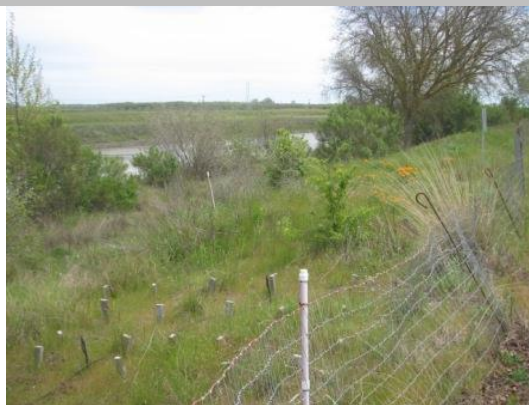
Photo 2 of 2 : SP_2019_NA0022_350_36_20190304_00018.jpg

Fence, irrigation and stakes in the revegetation site.

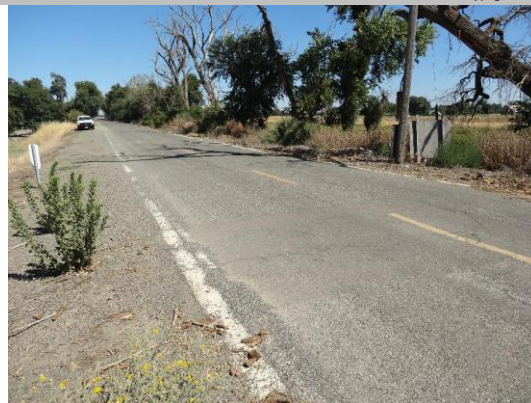
Photo 3 of 3 : UCIP_SP_2019_52728_75759.jpg

Comment Code						
Inspector Comment						
FS_ID:52728 DS_ID:19537 EP_NO: 18298 Repair Type: Urgent Crossing Status: Found UCIP Comments: 7/17/2018 Subsidence around siphon breaker on LS is present, although didn't increase in diameter. Water pump was running during site visit, small leak from pipe connection was observed on LS. (O.Yakimov-DWR UCIP)7/13/2016 same as last inspection - hole is still present near siphon breaker. Dense vegetation present and limits the inspector's visibility to identify signs of pipe failure (leaks) along the WS and LS slopes. Recommend removing vegetation along pipe alignment to conduct proper inspection of structure and appurtenances. (DWR UCIP - omagana)3/04/2014 Subsidence visible where siphon breaker is located on landward side. Unable to determine if subsidence is due to poor compaction or leak at siphon breaker. Need to contact owner to address issue. (DWR UCIP - omagana) FIELD_STRUCT_DESC: 14-inch coated steel water pipe through the levee, 2 feet below the crown. Pump platform is supported by 6 pilings on the waterside (WS) slope. Siphon breaker and air release valve on the landside (LS) shoulder. Concrete distribution box on the LS toe. Rock riprap along the WS slope. (Permit No. 18298, 2007 - Heidrick, [permit not in database]). FS Date: 7/17/2018 11:31:53 AM

Overview of pipe crossing looking upstream.

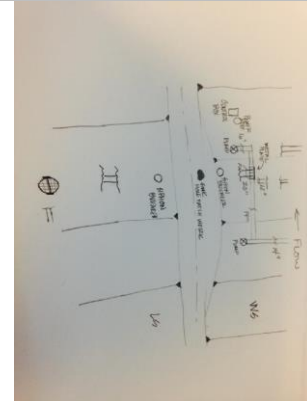
Photo 1 of 3 : UCIP_SP_2019_52729_58451.jpg

FS_ID:52729
DS_ID:19531
EP_NO: 9408
Repair Type: Urgent
Crossing Status: Found
UCIP Comments: 07/17/2018 No change from previous inspection. Patch repair of pavement on levee crown is in the same condition. Good candidate for internal inspection. (O.Yakimov-DWR UCIP)10/24/2017 Received updated photos from DWR levee inspector, Z. Jojola, and the photos show some depression along LS slope. Road patch repair is still visible on levee road, recommend an internal integrity inspection of pipe to determine the condition through the levee and slopes. (DWR UCIP - O. Magana) 07/13/2016 Same as last inspection. Sink hole repair visible on levee road. Recommend contacting owner to determine if an internal integrity inspection of the pipe was completed to confirm sink hole was not the cause of the damage to road. If no internal integrity inspection was completed during road repair, recommend an internal integrity inspection be completed at this location based on the sink hole that developed along pipe alignment and based on age of pipe. (DWR UCIP - omagana)03/04/2014 Signs of sink hole repair on levee crown. Owner will need to contact CVFPB to address sink hole repair. (DWR UCIP - omagana)

Plan view of crossing and appurtenances at CLM 4.692.

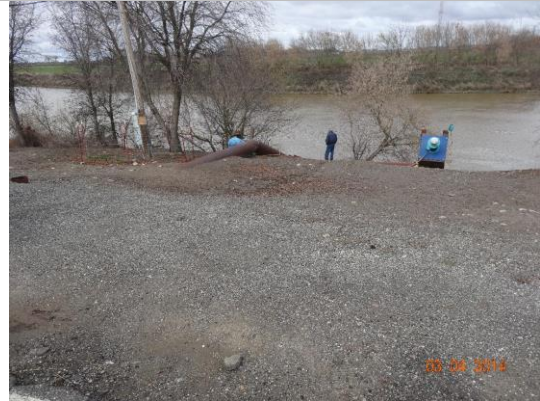
Photo 2 of 3 : UCIP_SP_2019_52729_58455.jpg

FS_ID:52729
DS_ID:19531
EP_NO: 9408
Repair Type: Urgent
Crossing Status: Found
UCIP Comments: 07/17/2018 No change from previous inspection. Patch repair of pavement on levee crown is in the same condition. Good candidate for internal inspection. (O.Yakimov-DWR UCIP)10/24/2017 Received updated photos from DWR levee inspector, Z. Jojola, and the photos show some depression along LS slope. Road patch repair is still visible on levee road, recommend an internal integrity inspection of pipe to determine the condition through the levee and slopes. (DWR UCIP - O. Magana) 07/13/2016 Same as last inspection. Sink hole repair visible on levee road. Recommend contacting owner to determine if an internal integrity inspection of the pipe was completed to confirm sink hole was not the cause of the damage to road. If no internal integrity inspection was completed during road repair, recommend an internal integrity inspection be completed at this location based on the sink hole that developed along pipe alignment and based on age of pipe. (DWR UCIP - omagana)03/04/2014 Signs of sink hole repair on levee crown. Owner will need to contact CVFPB to address sink hole repair. (DWR UCIP - omagana)

View of WS.

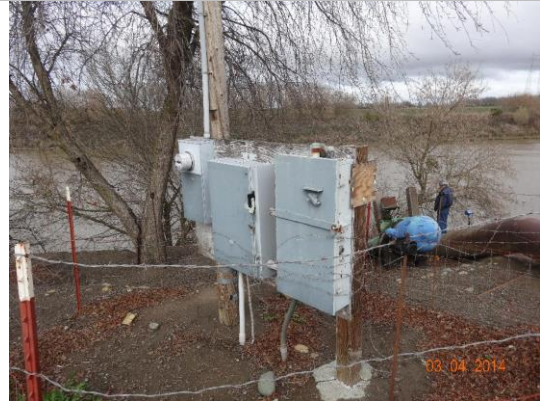
Photo 3 of 3 : UCIP_SP_2019_52729_58459.jpg

FS_ID:52729
DS_ID:19531
EP_NO: 9408
Repair Type: Urgent
Crossing Status: Found
UCIP Comments: 07/17/2018 No change from previous inspection. Patch repair of pavement on levee crown is in the same condition. Good candidate for internal inspection. (O.Yakimov-DWR UCIP)10/24/2017 Received updated photos from DWR levee inspector, Z. Jojola, and the photos show some depression along LS slope. Road patch repair is still visible on levee road, recommend an internal integrity inspection of pipe to determine the condition through the levee and slopes. (DWR UCIP - O. Magana) 07/13/2016 Same as last inspection. Sink hole repair visible on levee road. Recommend contacting owner to determine if an internal integrity inspection of the pipe was completed to confirm sink hole was not the cause of the damage to road. If no internal integrity inspection was completed during road repair, recommend an internal integrity inspection be completed at this location based on the sink hole that developed along pipe alignment and based on age of pipe. (DWR UCIP - omagana)03/04/2014 Signs of sink hole repair on levee crown. Owner will need to contact CVFPB to address sink hole repair. (DWR UCIP - omagana)

Power pole, meter box, & pump control panels located on WS.

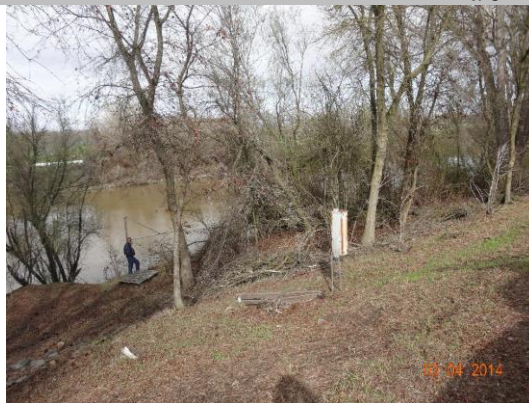
Photo 1 of 3 : UCIP_SP_2019_31927_58332.jpg

Comment Code					
Inspector Comment					
FS_ID:31927 DS_ID:19532 EP_NO: 3811 Repair Type: Non-Urgent Crossing Status: Found UCIP Comments: Unable to confirm is crossing is still in use. Need to contact owner to determine status of crossing. FIELD_STRUCT_DESC: 10-inch steel irrigation discharge pipe through the levee, 3.6 feet below the crown. Pump at the waterside (WS) toe on the riverbank. Standard cutoff wall around the pipe at the center of the levee. Standpipe at the landside (LS) toe. Siphon breaker on the LS shoulder. This crossing replaces the previous USACE O&M irrigation pipe referenced at Station 27+49. (Plans to replace a pump, suction pipe, and discharge pipe of an existing pump on the bank authorized under Permit No. 3811, 1962 - Gus Inglin, care of E. E. Luhdorff Company). [Additional Reference(s): DWR Levee Log, 2005. USACE Sacramento O&M Manual 127, June 1953, (Station 27+49)]. FS Date: 3/4/2014

View of waterward side.

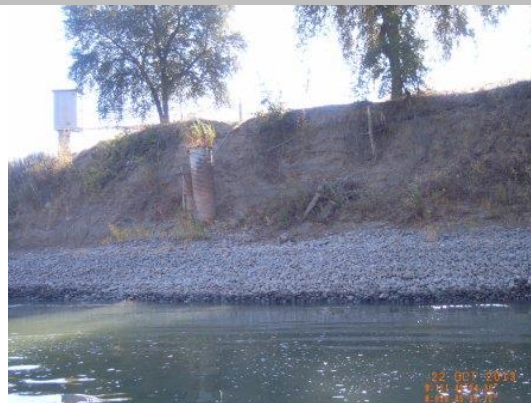
Photo 2 of 3 : SP_2019_NA0022_350_46_20190304_00024.jpg

Comment Code					
Inspector Comment					
2017 Site ID: SAC 83.9 R					
Status: Eroding					
2017 Field Notes: Fresh erosion on lower bank.					
Site History: 2006 - Approximately 18 to 20 ft of bank near levee at the corner of the levee and the Freemont Weir. Vertical bank with undercutting/mass failure. 2007 - Staked at top of bank for monitoring.					
2011 - Site has become significantly worse with more of the toe and lower bank eroded. Many trees have fallen since last year. 2012 - Site looks worse with more ersion around trees. 2013 - Additional erosion into the toe. 2015 - Site extended upstream about 500 ft to account for eroding bank. 2016 - Site continues to erode. Multiple trees appear ready to fall into the river.

USACE 2013 Photo #2

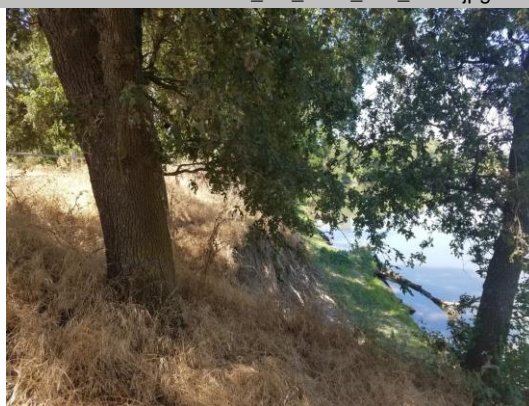
Photo 1 of 1 : LEVAL_SP_2019_490_4925.jpg

LM Start	5.85	Rating **	A/W	Issue No.	57
LM End		Issue Type +	Ma	Location *	
Category	Supplemental			GPS Latitude/Longitude	
				Start	End
Item	2017 Storm Damage			38.759100 °	°
				-121.667964 °	°
DWR ID	DWR_NA0022_01_f_2017_57				
Comment Code					
Inspector Comment					
Levee Evaluation Comments					
Description:Immediately U.S. of Fremont Weir					
Site ID No:490					
Site Designation:LMA-328					
Repair Type: Erosion					
Rating:Serious					
Field Date:7/27/2017					
Notes: wide crown. Erosion not in prism. May be a new erosion pocket, but need to compare to fsrp data. Old veg still present.
